Stairs Built to Last

by John Leeke

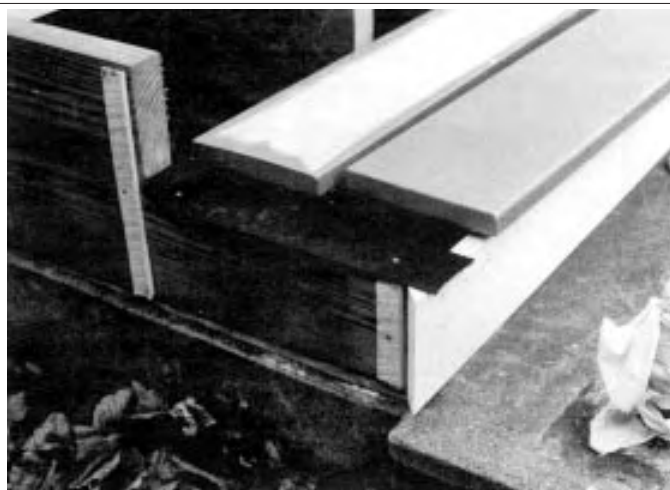
Figure 2. Details of construction. Vertical strips space the end trim boards out from the stringers to allow ventilation. Lead flashing under the stringers and tar paper over the stringer tread cuts keep water out. Treads, risers, and other woodwork are all backprimed.

- I set lead flashing under the stringers and the bottom riser to prevent moisture from seeping from the concrete base into the wood.
- As I nailed on the treads, I laid tar paper over the stringer tread cuts to divert any water seeping between the tread boards (see Figure 2).
- I spaced each end trim board out

from the stringers to prevent water from being trapped between the two boards.

- I rounded all edges and corners with a $1/16$ -inch radius so the paint would form a continuous film around the edge. If edges are perfectly square, the paint film will be thinner at the edge and will weather away quickly, allowing water to penetrate. I also rounded the front edge of the treads with a $1/4$ -inch radius to prevent excessive wear.

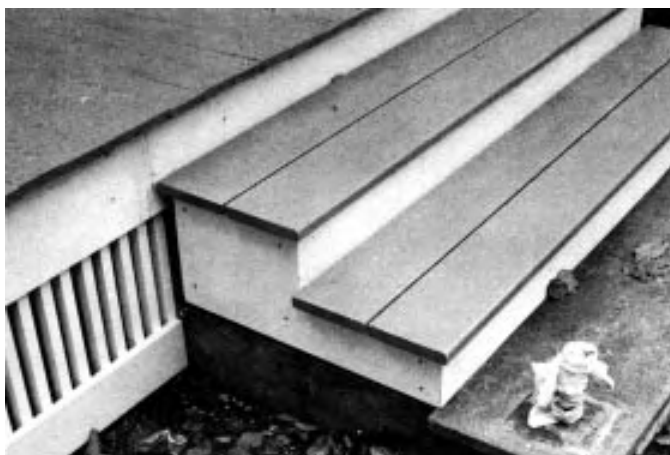
Figure 3. The finished steps fit in neatly with the rest of the porch — and will last.

the woodwork one top coat before installation. After installation the painters gave the steps an additional top coat (see Figure 3).

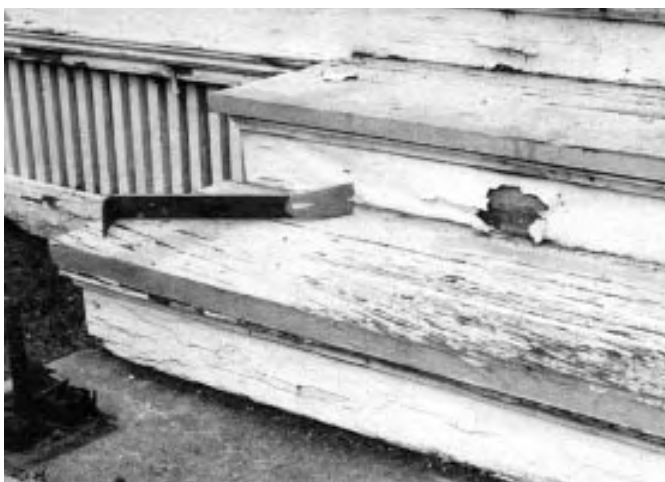
Decay had weakened the structural members underneath, so that the treads moved and shifted every time they were walked on. Peeling paint and checked wood gave the steps a shabby appearance (see Figure 1), but were only indications of the true problem, which was poor drainage.

In fact, a gutter downspout ended next to the house and had been dumping water underneath the porch for years. Also the landscaping around the edge of the porch had built up over the years, creating a reverse slope so that the water had nowhere to go. The excessive moisture was the root cause of the structural and finish damage to the steps.

Figure 1. Paint peeling down to bare wood indicates excessive moisture in the woodwork. The buckling paint on the second riser is a result of decay.

When the steps were completed I also installed a drainage system to eliminate the original cause of the moisture buildup.
