Porch Repair From The Bottom Up

The wrap-around porch on this 1860s house had rotten joists, backed-up gutters, and decaying columns—a typical neglected porch.

by Peter and Maureen Nicolazzi
For a complete cure, start with a thorough diagnosis

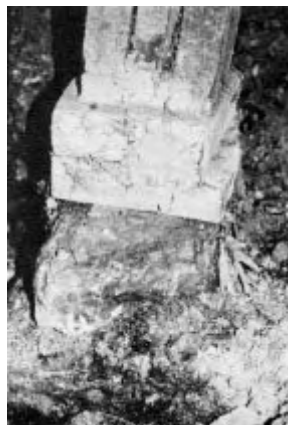
Figure 1. Dig down and you'll find surprises at footing level. This concrete footing, cracked apart, is resting on the original hunk of limestone.

Start by digging down to the footings. Make sure all the footings lie below frost line. Examine the footings and piers with an awl or pocket knife. If concrete, are they solid? If they're crumbling or severely cracked, they'll need to be replaced (see Figure 1). On this job we found every kind of footing imaginable. The most common footing

was, simply, six unmortared bricks, stacked criss-cross, a foot below ground. We also found cinderblock props, crumbling concrete, and wood blocks.

Footings and piers. You can't do structural work until you have good footings beneath the structure. Brick or block footings and piers can be repaired by repointing, if the masonry is in good shape. If the piers are exposed and an important design element of the porch, find a mason who can mix mortar to match the old. Wide Brixton joints will spoil the appearance of a repair job. If you need to replace piers, concrete footings and piers (if historically acceptable) would be the route we'd go. Replacement requires jacking and temporary supports. If the beam above the posts is solid, you can set jacks under the beam (see Figure 4). If the beam is not solid, jack under the floor joists (see Figure 5). Jacking under the floor joists will also let you replace the beams as needed. We used hydraulic jacks (22-ton) because we didn't have much working room under the porch. (The long handle of a screw jack won't work in tight spaces.) Hydraulic jacks are easy to move around, but you can't trust them completely, so we always shore with a solid post to solid blocking. We use 4x4, 6x6, or 8x8 jack posts with a 1/4-inch steel plate (the same size as the post) on top of the jack. The steel keeps the jack from driving into the end grain. We place the jacks on cribbing so we don't drive them into the ground.

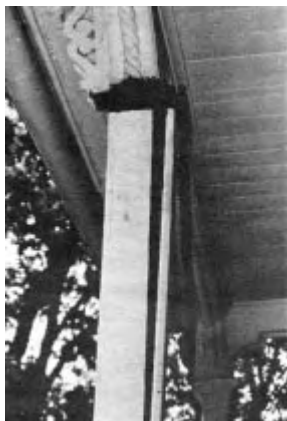
Figure 2. Columns wrapped in 1x stock conceal hidden damage. Take the columns apart very carefully because much of the material can be reused.

Inspect the columns and balustrade. With solid columns, you'll have to make sure the lumber is structurally sound by poking the column base with a scratch awl. Here we had boxed columns, so we opened them up to check the internal structural member (see Figure 2). These were supposed to be supporting the roof structure. Instead we found that the built-in gutters above had rusted through, turning the tops of the columns into a funnel.

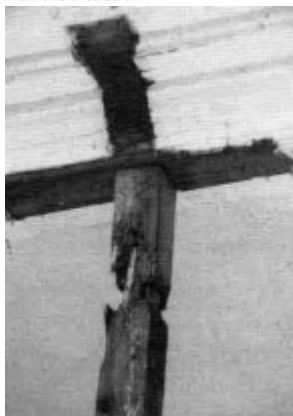
Figure 3. The post looks like it's been nibbled by beaver, but it's actually water damage.

Water had funneled from the roof into the entire lower structure and caused extensive damage (see Figure 3).

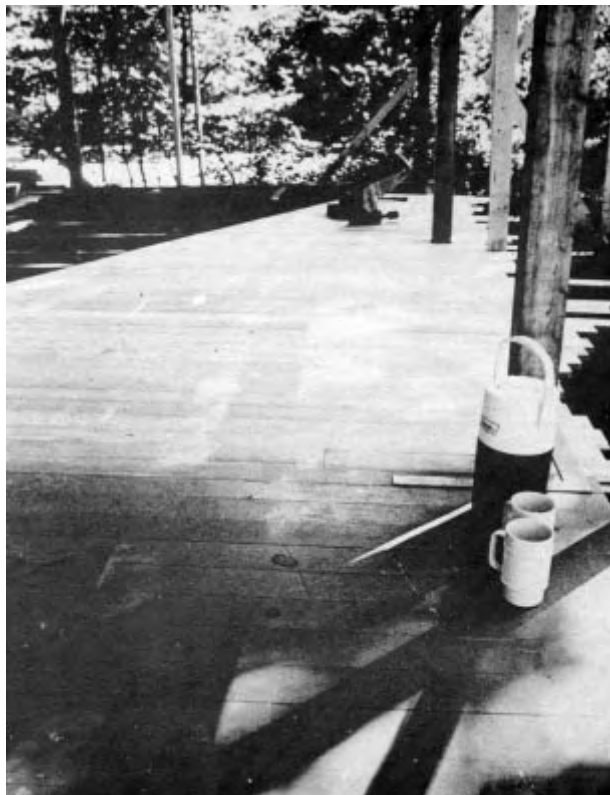
Figure 7. The thermos jug marks the spot where new tongue-and-groove porch flooring begins. Douglas fir flooring to match the old is still available.

Floor. We replaced sections of the tongue-and-groove flooring with douglas fir porch flooring (see Figure 7). We prime the new floor boards before they go in—edges too. We swear by

Benjamin Moore's "Maxim." It's used to maintain a wooden roller coaster at our local amusement park, and it's worked great for us as a primer. You can go over it with any kind of oil paint.
